Sloan® Flushometer

PARTS LIST

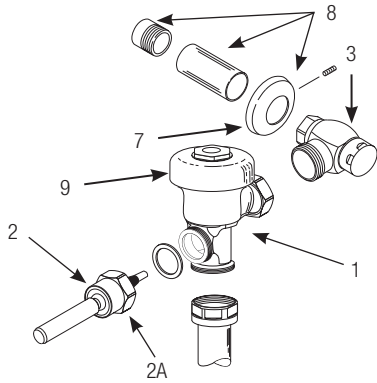
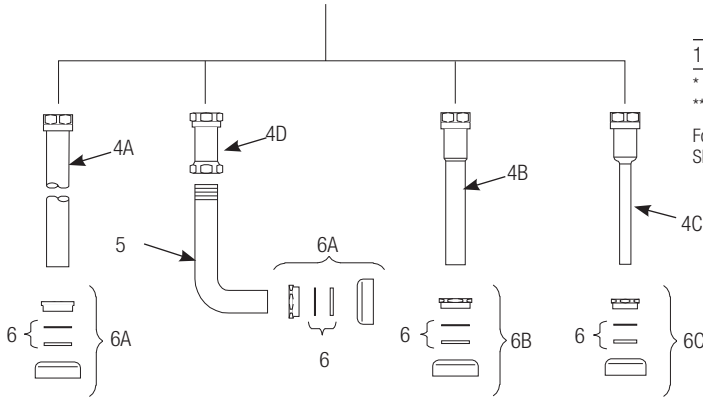
Item No.	Code No.	Part No.	Description
1.	—	A-3-A	Valve Assembly – contact Tech Support for proper assembly
2.	0302390	B-73-A	ADA Compliant Handle Assembly
2A.	0301082	A-6	CP Handle Coupling

3.	—	H-710-A	Bak-Chek® Control Stop – 3/4" or 1"
4A.	5323007	V-500-AA	1-1/2" (38 mm) x 9" (229 mm) Vacuum Breaker Assembly ** – 6 per package
4B.	5323006	V-500-AA	1-1/4" (32 mm) x 9" (229 mm) Vacuum Breaker Assembly – 6 per package
4C.	5323005	V-500-AA	3/4" (19 mm) x 9" (229 mm) Vacuum Breaker Assembly – 6 per package
4D.	—	V-500-A	Vacuum Breaker Assembly

5.	0396293	F-109	1-1/2" (38 mm) Elbow Flush Connection
6.	SEE SLIP JOINT GASKETS AND RINGS TABLE BELOW		
6A.	0306145	F-56-A	1-1/2" (38 mm) Spud Coupling Assembly
6B.	0306142	F-55-A	1-1/4" (32 mm) Spud Coupling Assembly
6C.	0306102	F-54-A	3/4" (19 mm) Spud Coupling Assembly

7.	—	F-7	Supply Flange (Supplied when Valve is not Ordered with Sweat Solder Kit)
8.	3308782	H-633-AA	1" (25 mm) Sweat Solder Kit with Cast Set Screw Flange
	3308788	H-636-AA	3/4" (19 mm) Sweat Solder Kit with Cast Set Screw Flange

9.	0378000PKSV-10		CP Sloan Cover
	0378003PKSV-10-HE		CP High Efficiency Sloan Cover
10.	3388015	H-1015	Flow Control Kit (not Shown)(HEU Only)

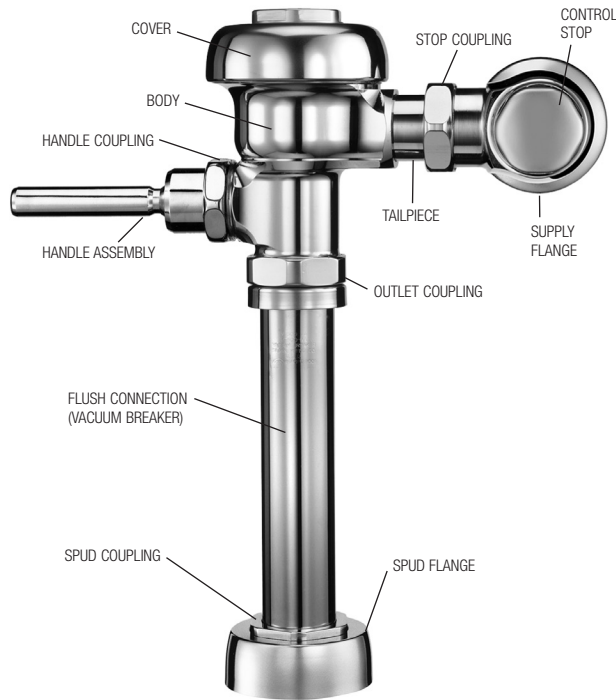
DIAPHRAGM INSIDE PARTS KITS (SEE ILLUSTRATION BELOW)

Refer to Parts List. Includes Relief Valve and Diaphragm Assembly

Item No.	Code No.	Part No.	Application
A.	3378041	SV-41-A	1.6 gpf/6.0 Lpf - Closet
B.	3378038	SV-38-A	3.5 gpf/13.2 Lpf - Closet
C.	3378044	SV-44-A	2.4 gpf/9.0 Lpf - Closet
D.	3378037	SV-37-A	1.5 gpf/5.7 Lpf - Urinal
E.	3378042	SV-42-A	1.0 gpf/3.8 Lpf - Urinal
F.	3378043	SV-43-A	0.5 gpf/1.9 Lpf - Urinal
G.	3378047	SV-47-A	1.28 gpf/4.8 Lpf - Closet

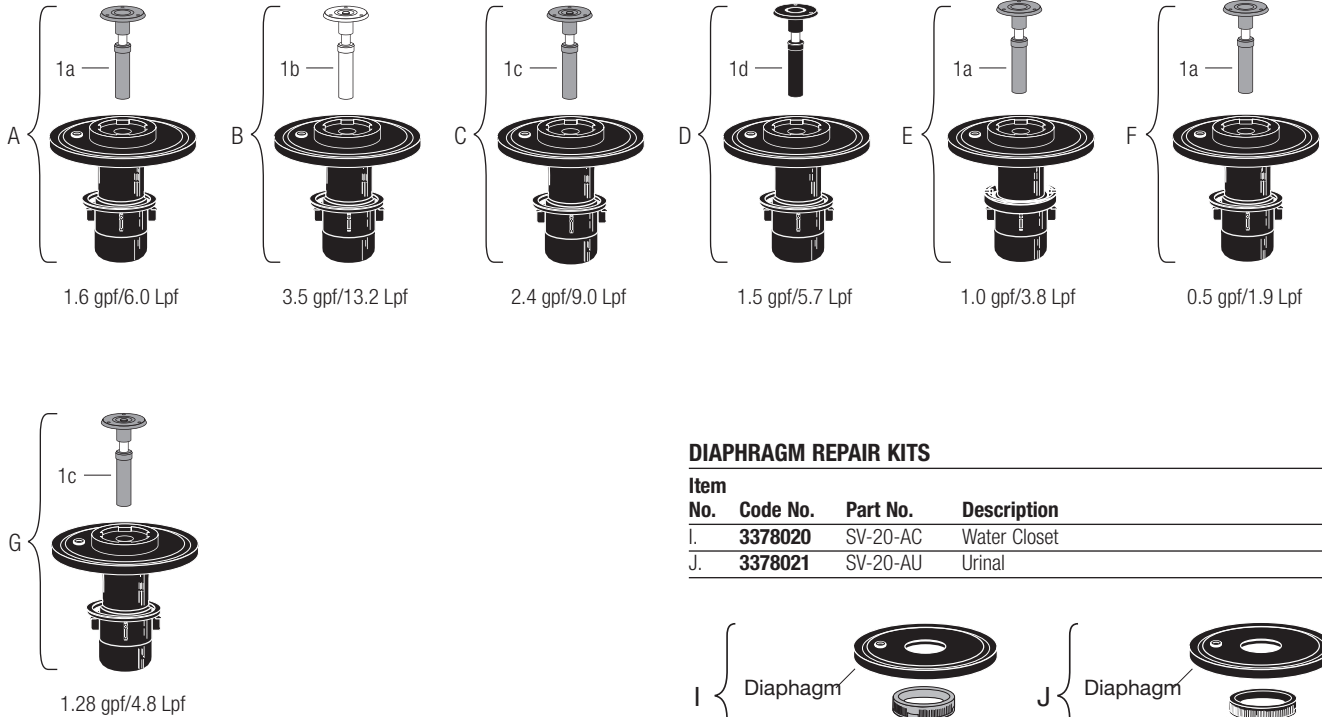
INSIDE COMPONENTS

Item No.	Code No.	Part No.	Description
1a.	5301211	A-19-ALC	Relief Valve, Green (Closet/Urinal-LC) – 12 per package
1b.	5301058	A-19-AC	Relief Valve, White (Closet) – 12 per package
1c.	0301143	A-19-AL	Relief Valve, Blue (9 Liter Closet)
1d.	5301059	A-19-AU	Relief Valve, Black (Urinal) – 12 per package

Item No.	Code No.	Part No.	Description
I.	3378020	SV-20-AC	Water Closet
J.	3378021	SV-20-AU	Urinal
