## Gem-2® Flushometer

### PARTS LIST

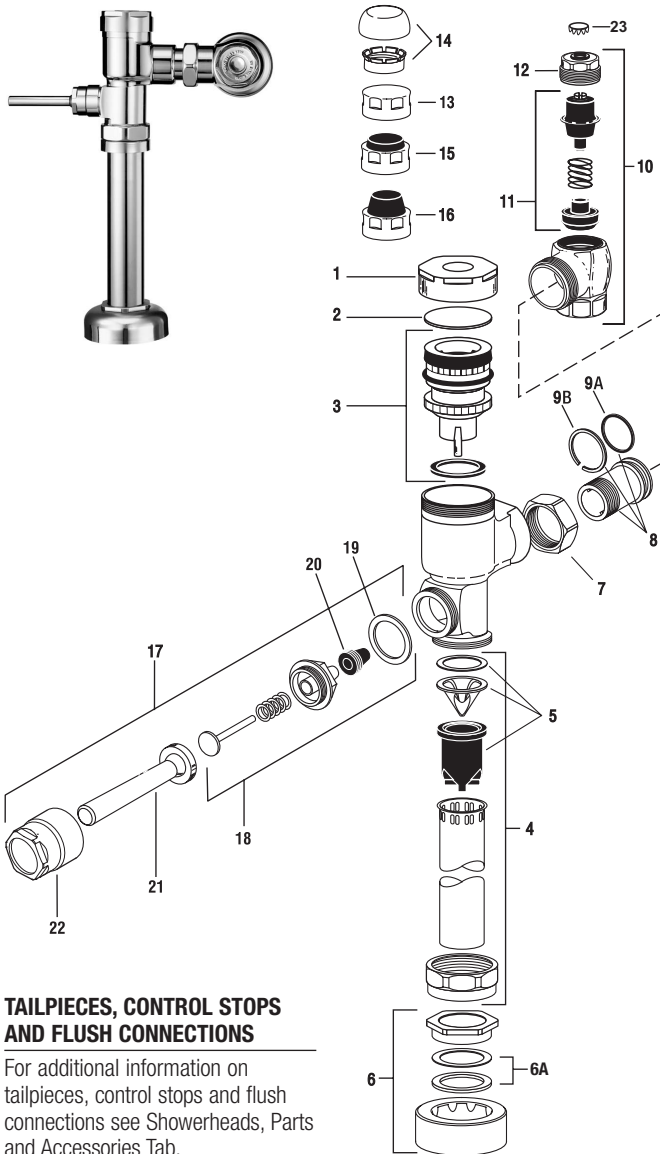
Item No.	Code No.	Part No.	Description
1.	<b>0307142PK</b>	G-105	CP Cover
2.	<b>0307139</b>	G-106	Slip Disc
3.	<b>3307135</b>	G-1022-A	Piston Kit – 1.28 gpf/4.8 Lpf Water Closet
	<b>0307193</b>	G-1007-A	Piston Kit – 3.5 gpf/13.2 Lpf Water Closet
	<b>0307195</b>	G-1016-A	Piston Kit – 1.6 gpf/6 Lpf Water Closet
	<b>0307192</b>	G-1009-A	Piston Kit – 1.5 gpf/5.7 Lpf Urinal
	<b>0307185</b>	G-1017-A	Piston Kit – 1.0 gpf/3.8 Lpf Urinal
	<b>3307133</b>	G-1018-A	Piston Kit – 0.5 gpf/1.9 Lpf Urinal
	<b>3307134</b>	G-1019-A	Piston Kit – 2.4 gpf/9.0 Lpf Water Closet
	<b>3307136</b>	G-1023-A	Piston Kit – 0.125 gpf/0.5 Lpf Urinal
	<b>3307137</b>	G-1024-A	Piston Kit – 0.25 gpf/1.0 Lpf Urinal

4.	<b>5323005</b>	V-500-AA	3/4" x 9" Vacuum Breaker – 6 per package
	<b>5323006</b>	V-500-AA	1-1/4" x 9" Vacuum Breaker – 6 per package
	<b>5323007</b>	V-500-AA	1-1/2" x 9" Vacuum Breaker – 6 per package

5.	<b>3323192</b>	V-551-A	Vacuum Breaker Repair Kit
6.	<b>3332002</b>	CR-1010-A	1-1/2" (38 mm) Spud Coupling
	<b>3332001</b>	CR-1009-A	1-1/4" (32 mm) Spud Coupling
	<b>3332000</b>	CR-1008-A	3/4" (19 mm) Spud Coupling
6A.	<b>SEE SLIP JOINT GASKETS AND RINGS TABLE BELOW LEFT</b>

7.	<b>0308676PK</b>	H-550	Stop Coupling
8.	<b>0308801</b>	H-551-A	Adjustable Tailpiece 2-1/16" (Standard Length)
9A.	<b>5308696</b>	H-553	O-ring – 24 per package
9B.	<b>5308381</b>	H-552	Locking ring – 12 per package

10.	<b>3308876</b>	H-790-A	1" Screwdriver Bak-Chek® Stop CP – complete
	<b>3308875</b>	H-790-A	3/4" Screwdriver Bak-Chek® Stop CP – complete
11.	<b>3308853</b>	H-541-A	Control Stop Repair Kit*
	<b>3308856</b>	H-543-A	Control Stop Repair Kit**

12.	<b>0308612PK</b>	H-622	CP Bonnet*
	<b>0308843</b>	H-577	CP Bonnet** – DISCONTINUED
13.	<b>3308840</b>	H-573-A	Control Stop Cap**
14.	<b>3388017</b>	H-1017	Flow Control (HEU Only) (Not Shown)

15.	<b>3308866</b>	H-574	Control Stop w/Bumper (-YO Variation)*
16.	<b>3308867</b>	H-576	Control Stop w/Extended Bumper (-YG Variation)*

17.	<b>0307100</b>	G-143	Handle Assembly
18.	<b>5307074</b>	G-50-A	Handle Repair Kit – 6 per package
19.	<b>5307065</b>	G-35	Handle Gasket – 48 per package
20.	<b>5302297</b>	B-39	Handle Seal – 12 per package
21.	<b>0307024PK</b>	G-145	Handle Grip
22.	<b>0307020PK</b>	G-144	Handle Socket
23.	<b>5388002</b>	H-528	Control Stop Plug CP* (12 per pack)

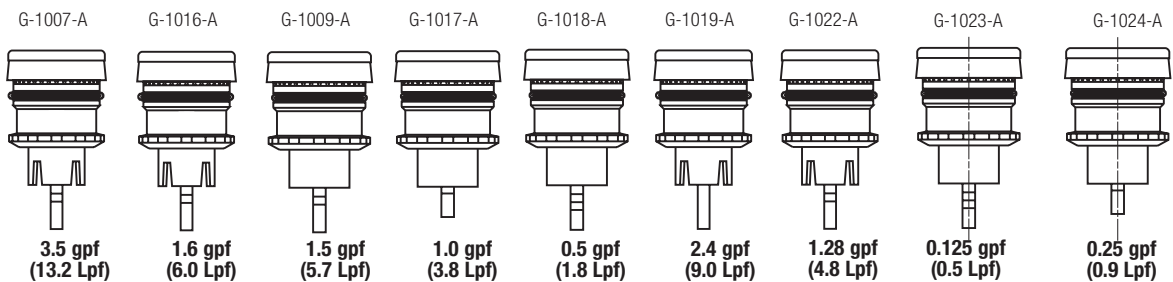
Gem-2 Pistons can be identified by the color, shape and marking of the above components.

Code No.	Part No.	Description	Cover Color	Piston Color	Barrel	Grooves
<b>0307193</b>	G-1007-A	3.5 gpf (13.2 Lpf) – Water Closet	White	Gray	Slotted	2
<b>0307195</b>	G-1016-A	1.6 gpf (6.0 Lpf) – Water Closet	Green	Green*	Slotted	2
<b>0307192</b>	G-1009-A	1.5 gpf (5.7 Lpf) – Urinal	Black	Black	Solid	2
<b>0307185</b>	G-1017-A	1.0 gpf (3.8 Lpf) – Urinal	Yellow	Black	Solid	1
<b>3307133</b>	G-1018-A	0.5 gpf (1.8 Lpf) – Urinal	Red	Black	Solid	3
<b>3307134</b>	G-1019-A	2.4 gpf (9.0 Lpf) – Water Closet	Blue	Gray	Slotted	0
<b>3307135</b>	G-1022-A	1.28 gpf (4.8 Lpf) – Water Closet	Deep Purple	Tan*	Slotted	2
<b>3307136</b>	G-1023-A	0.125 gpf (0.5 Lpf) – Urinal	Pink	Burgundy	Solid	3
<b>3307137</b>	G-1024-A	0.25 gpf (0.9 Lpf) – Urinal	Burgundy	Burgundy	Solid	1

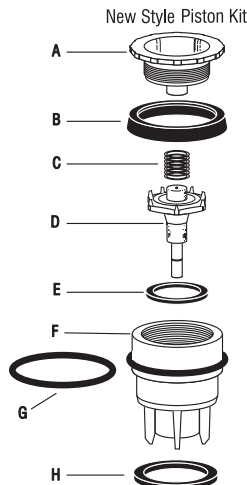
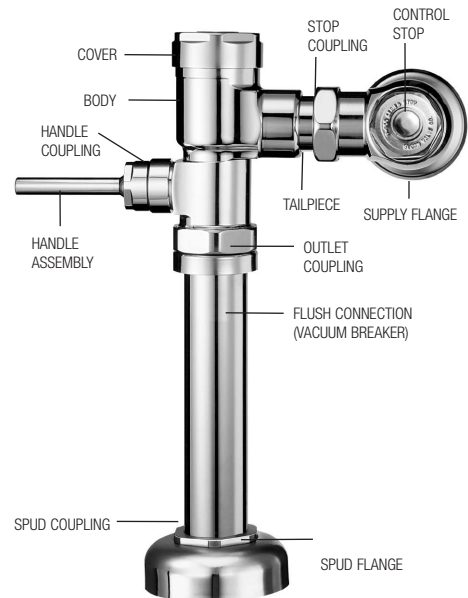
### ITEM 3. PISTON COMPONENTS

Item	Code No.	Part No.	Description
A.	***	***	Piston Cover
B.	<b>5307106</b>	G-78	Molded Cup – 12 per package
C.	<b>0307130</b>	G-102	Spring
D.	***	***	Relief Valve
E.	<b>0307116</b>	G-95	Relief Valve Seat
F.	***	***	Piston Body
G.	<b>0307210</b>	G-85	Filter O-ring
H.	<b>5307052</b>	G-21	Main Seat – 6 per package

Code No.	Part No.	Description
<b>3307128</b>	G-1011-A	Repair Kit includes Items: 2, B, C, E, G & H

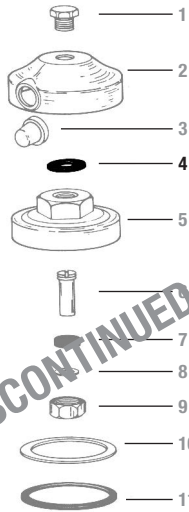
### REPAIR PARTS FOR OLD STYLE GEM FLUSHOMETERS (PRE-1985) Adjustable Cover

Item			
No.	Code No.	Part No.	Description
1.	—	G-24	CP Cover Screw – <b>DISCONTINUED</b>
2.	—	G-23	CP Cover – <b>DISCONTINUED</b>
	—	G-26	CP Cover for Bumper – <b>DISCONTINUED</b>
3.	—	G-27	Bumper (12 per package) – <b>DISCONTINUED</b>
4.	<b>0307058</b>	G-25	Cover Gasket (12 per package)
5.	—	G-4	RB Inside Cover – <b>DISCONTINUED</b>
6.	—	G-6	RB Regular Screw – <b>DISCONTINUED</b>
7.	—	S-26	Packing <b>DISCONTINUED</b>
8.	—	S-24	Packing Disc <b>DISCONTINUED</b>
9.	—	G-10	RB Packing Nut – <b>DISCONTINUED</b>
10.	—	G-65	Gasket – <b>DISCONTINUED</b>
11.	—	G-5	Gasket <b>DISCONTINUED</b>

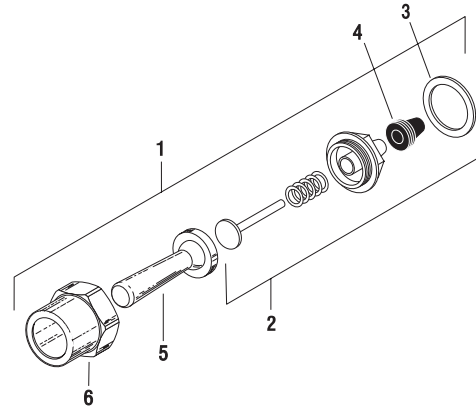
### REPAIR PARTS FOR OLD STYLE PISTON

Item			
No.	Code No.	Part No.	Description
12.	<b>0307105PK</b>	G-77	Piston Cover
13.	<b>5307106</b>	G-78	Molded Cup* (12 per pack)
14.	<b>0307113</b>	G-84	Spring <b>OBSOLETE</b>
15.	<b>0307110</b>	G-81-A	Relief Valve
16.	<b>0307112</b>	G-83	Relief Valve Seat
17.	—	G-75	Closet Piston Body
	—	G-76	Urinal Piston Body
18.	<b>0307052</b>	G-21	Main Seat
